Title: DISCHARGE CHUTE FOR
CONCRETE

**Declaration of Thomas Quigley, Scott Steckling and Troy Scott
under 37 C.F.R. §1.131**

ENGINEERING TECHNICAL REPORT

SUBJECT: Chute Strength Test REQUESTED BY: Tom Quigley

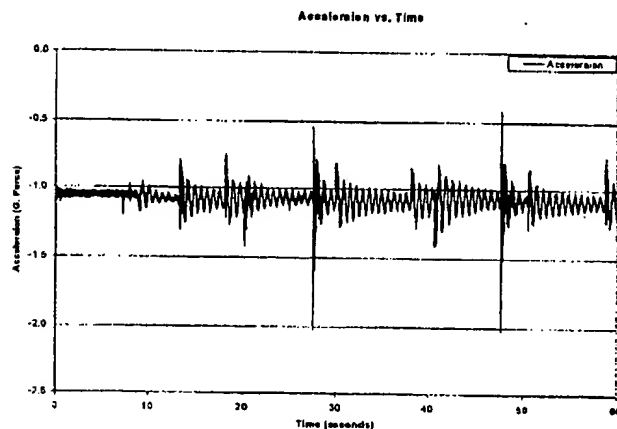
Figure 3: This graph represents the acceleration forces acting on the MTM chutes during normal operations. The chutes were raised to the maximum vertical position and then down to the lowest position. This sequence was repeated twice. (chute up, down, up, down, up, down) The chutes were raised at normal operating speeds without bouncing. The accelerometer was mounted at the bottom of the third chute and approximately in the middle of the set of four chutes.

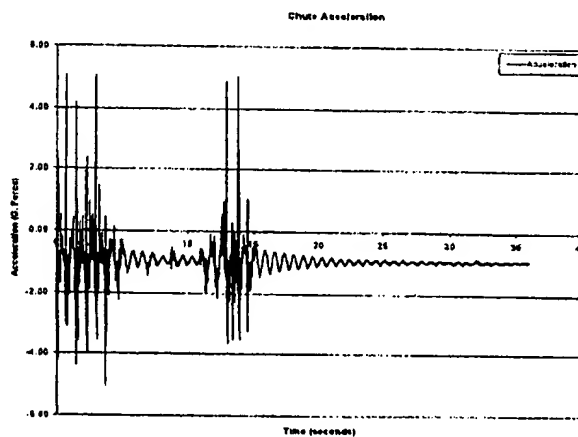
Figure 4: This graph is a representation of the acceleration forces acting on the MTM chutes during bouncing. In this case the chutes were bounced up and down once.

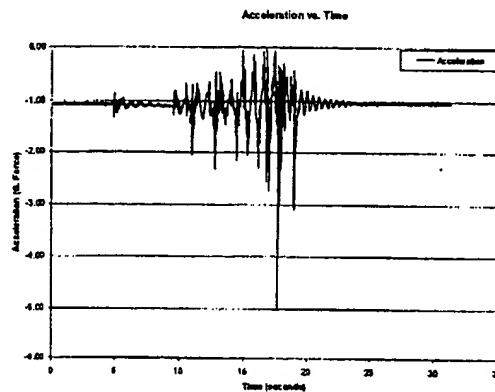
Figure 5: This graph represents the acceleration forces on the MTM chutes at the point of failure where the chutes buckled.

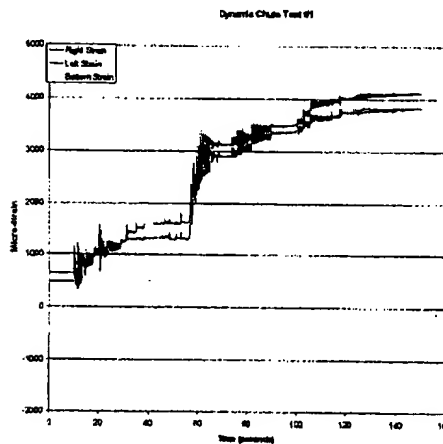
Figure 6: This graph illustrates the amount of strain in the side walls and bottom of the first chute during a Static Loading test.

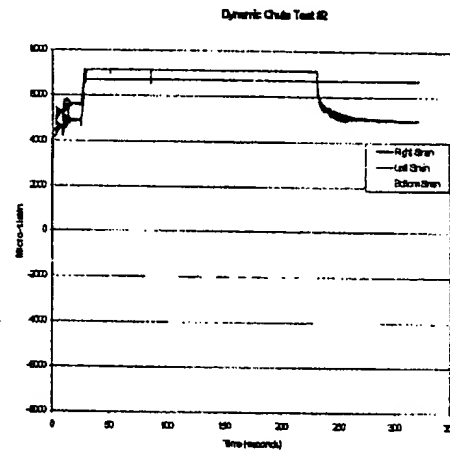
Figure 7: This graph is a continuation of figure 6. Here the chutes were dynamically tested until failure. The flat portion of the left and right strain is due to exceeding the limits of the testing equipment. Note that the material has entered the plastic range and does not start the test at zero.

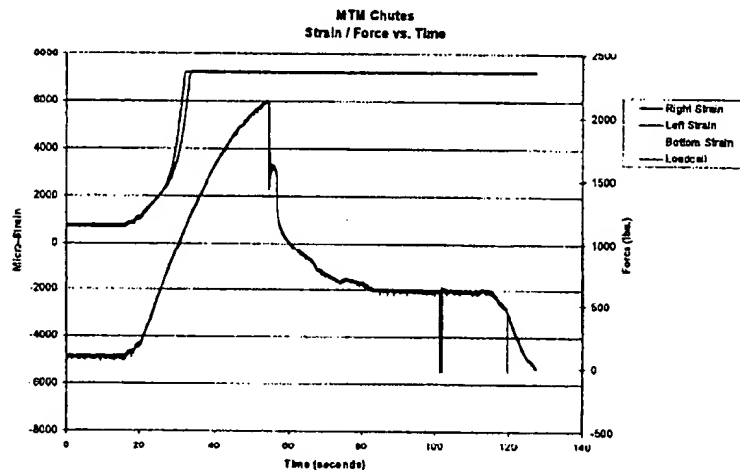
Figure 8: This graph shows both the recorded strain on the chute and the force being applied by the piston until failure. This MTM chute failed by buckling.

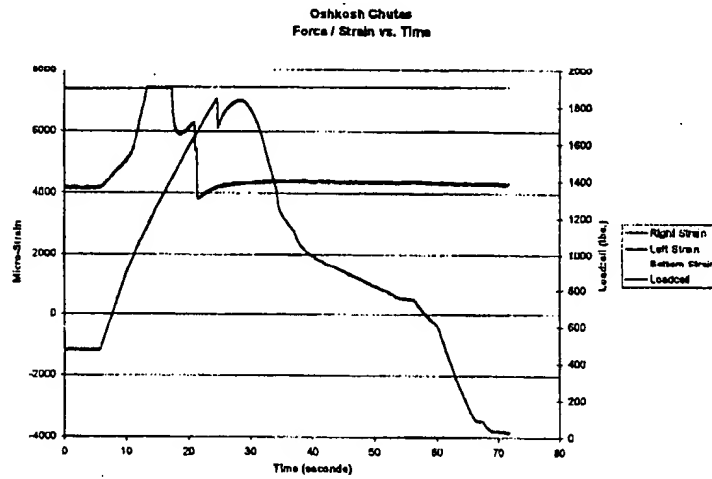
Figure 10: This graph shows both the recorded strain on the chute and the force being applied by the piston until failure. This Oshkosh chute failed by buckling.

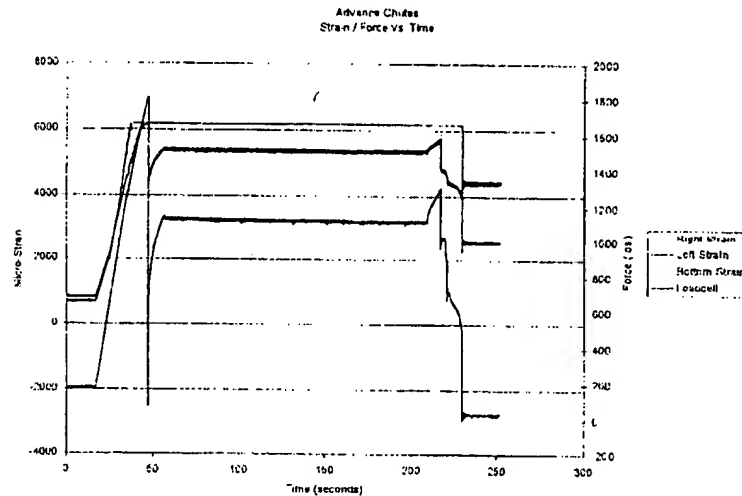
Figure 10: This graph shows both the recorded strain on the chute and the force being applied by the piston until failure. This Advance aluminum chute's failure was due to the bottom welds cracking and eventually shearing the metal. The flat region is due to a stop in the test when the chute was analyzed. This chute failed at the end farthest away from the truck.

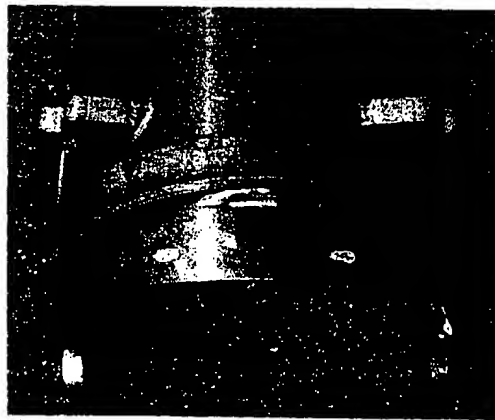
Figure 13: Failed Advance aluminum chute, Bed-Plate Pull Test

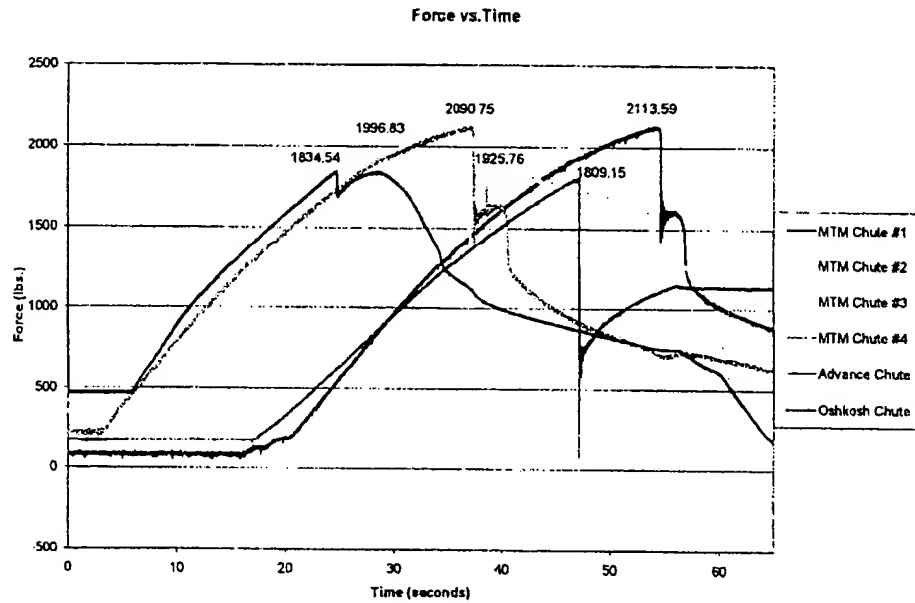
Figure 14: This graph compares the failure point strength of each chute tested including the Oshkosh and the Advance aluminum.
